PANAMA DAM

CHAUTAUQUA COUNTY NEW YORK
INVENTORY NO. N.Y. 784

**PHASE I INSPECTION REPORT
NATIONAL DAM SAFETY PROGRAM**

Name of Dam:	Panama Dam I.D. No. NY 784
State Located:	New York
County:	Chautauqua
Watershed:	Allegheny River Basin
Stream:	Little Brokenstraw Creek
Dates of Inspection:	October 3 and November 9, 1979

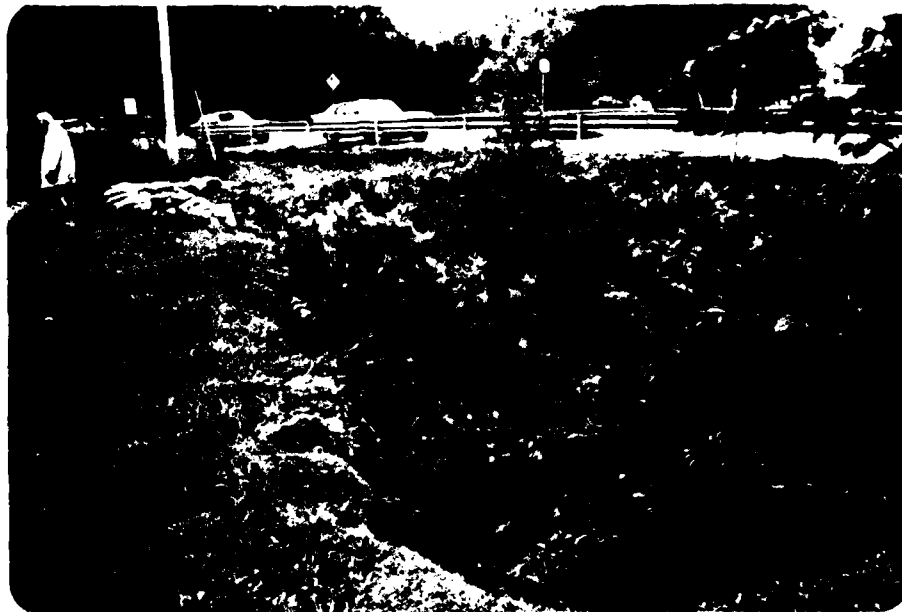
Right Embankment & Erosion Above 5'x5' Box Culvert
Photo #4

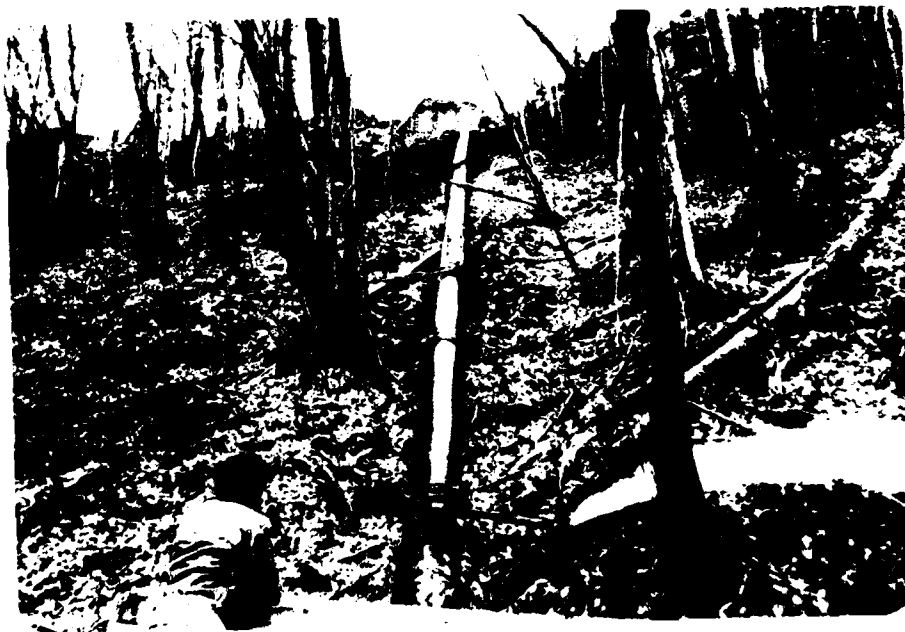
Penstock Viewed from Mill
Photo #7

the support for the 16" penstock near the highway is shifted approx.
8 inches, the pipe is rusted and several holes were evident

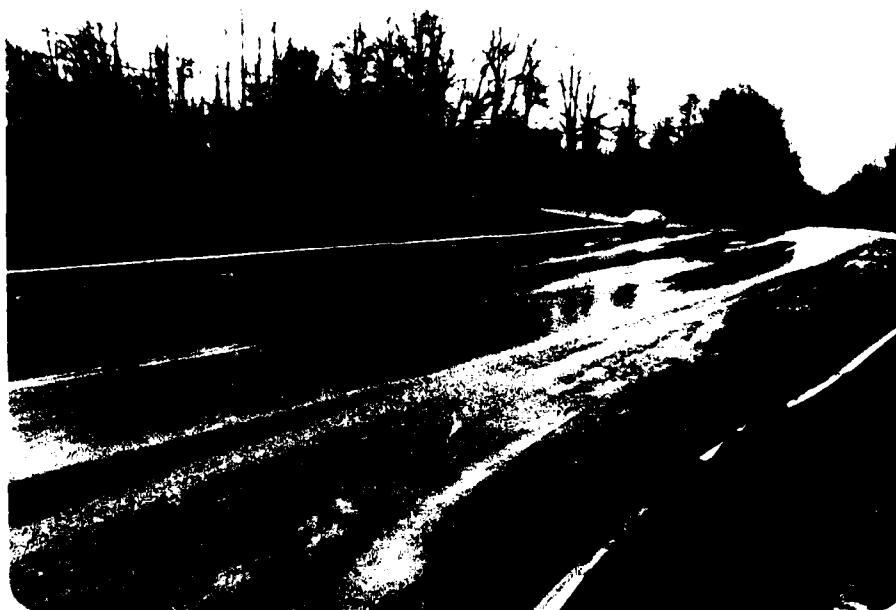
The highway embankment immediately below the dam appears stable. There was no evidence of movement, misalignment, seepage, surface cracks, erosion, or sloughing. Vegetative growth on the embankment must be removed to aid in future inspection of the area and avoid the problems associated with tree growth. (See Photos #9, 10 & 11)

Crest of Highway Embankment
Note Overtopping occurred by car
& flowed down highway at extreme right
Photo #9

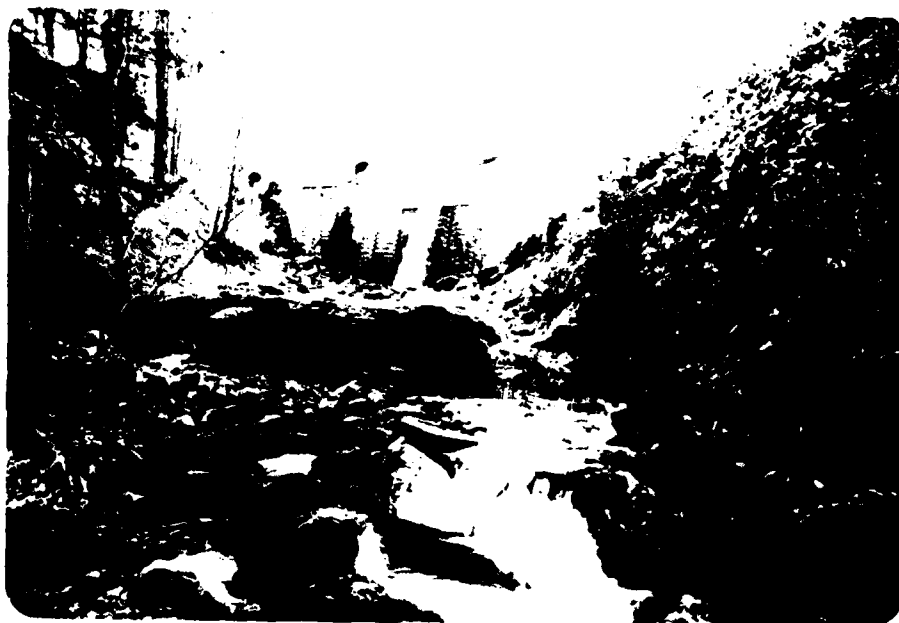
The downstream channel below the highway embankment is bedrock formed. Some debris and boulders were evident (See Photos #10 & 11) in the channel. The Little Brokenstraw Creek flows beneath the Lumber Mill (See Photos #12 & 13)

Highway Embankment viewed from
Downstream Channel
Photo #11

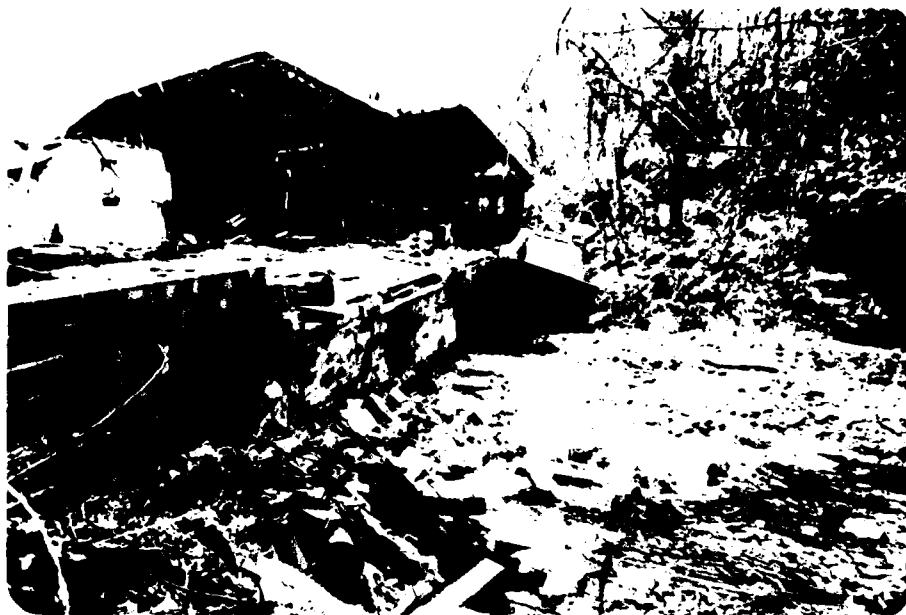
Burned-out Lumber Mill
Note flow beneath building
Photo #12
